Manhole Inspection Summary

Manhole # S35AA_014MH

Location Address: **690 n calvert st** Cross Street: **e monument st**

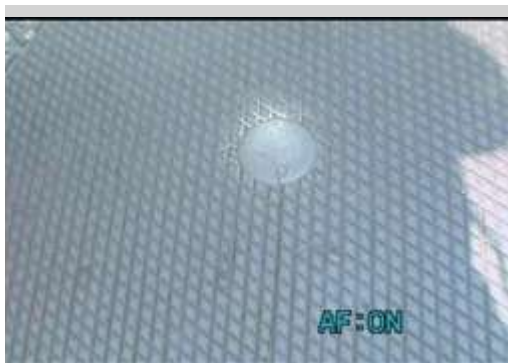
Misc 1

Type: **Sanitary** Condition: **Cracked** Cover Material: **Cast Iron**

crack goes all the way through to other side

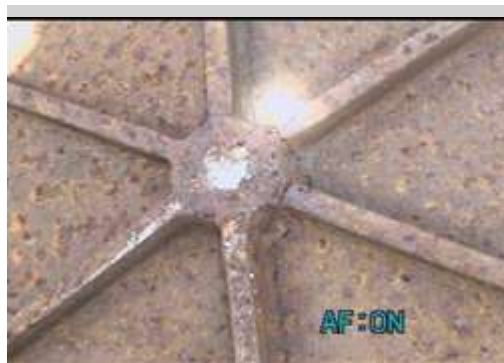
Defect 6

crack cover

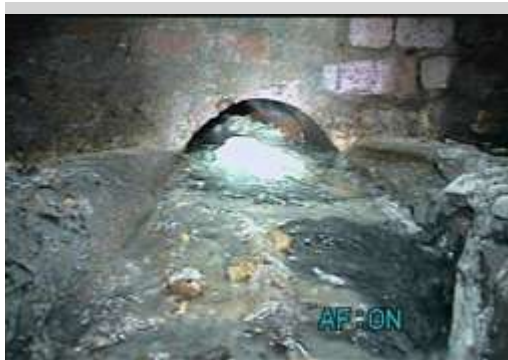
Defect 5

Condition: ☐ Sound ☐ Cracked ☐ Root Intrusion ☐ Deteriorated ☐ Leaks ☒ **Debris**

channel debris

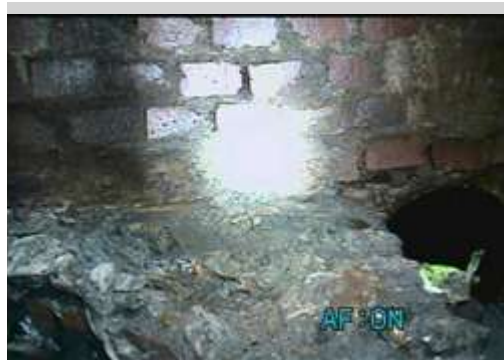
Defect 4

Condition: ☐ Sound ☐ Cracked ☐ Root Intrusion ☐ Deteriorated ☐ Leaks ☒ **Debris**

bench debris

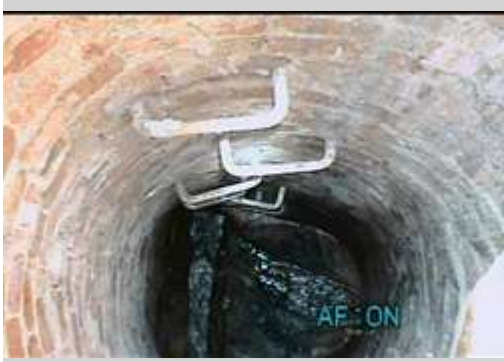
Defect 1

Steps Count: **7** Missing: **0** ☒ **Corroded**

corroded steps

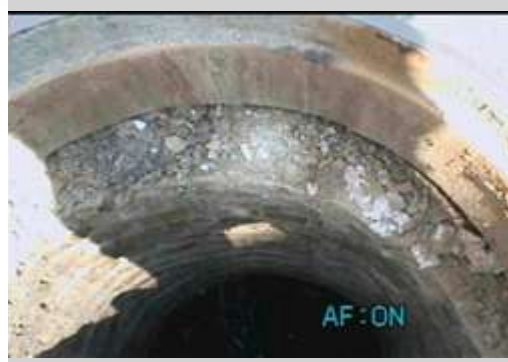
Defect 3

Frame Offset: **5** (in.) Condition: ☐ Sound ☐ Cracked ☒ **Leaks**

frame offset

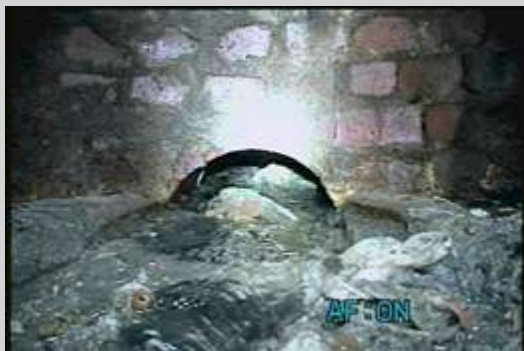
3 O'Clock Inflow

8 in. Circular Gravity Sewer
Pipe In @ 3 O'Clock

Deposits: ☐ None ☐ Mud ☐ Sludge ☒ **Debris** ☐ Grease

Silt Depth: 6 (in.) Deposits Extent: **Heavy**

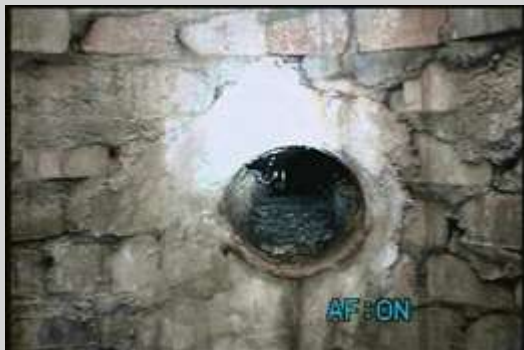
9 O'Clock Inflow

not a drop there is no pipe below it
